### 5.0 Repair Surveys

## 5.1 1992 Fuselage Repair Survey of Stored Airplanes

#### 5.2 1994 Repair Survey of In-service Airplanes

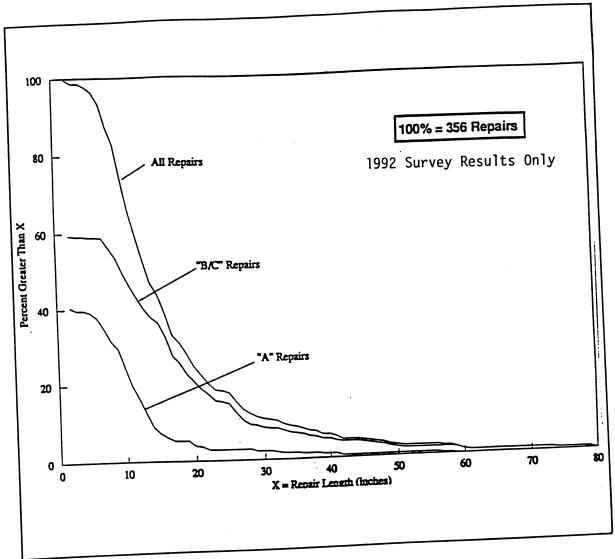
Figure 5.6 Fuselage Repair Size Distributions From 1992 Survey

The repair surveys did not indicate an immediate concern for continued structural airworthiness. The size distribution of repairs, Figure 5.6, indicated a need for assessments to establish inspection requirements for larger repairs and/or smaller repairs in close proximity. It was concluded that operators need updated SRMs and model specific guidance documents to accomplish their repair assessments.
